Department of Geology and Mineral Industries

Mineral Land Regulation & Reclamation

Site ID and Name: 07-0150, Sustainable Aggregate Resources

Date of Inspection: September 26, 2024

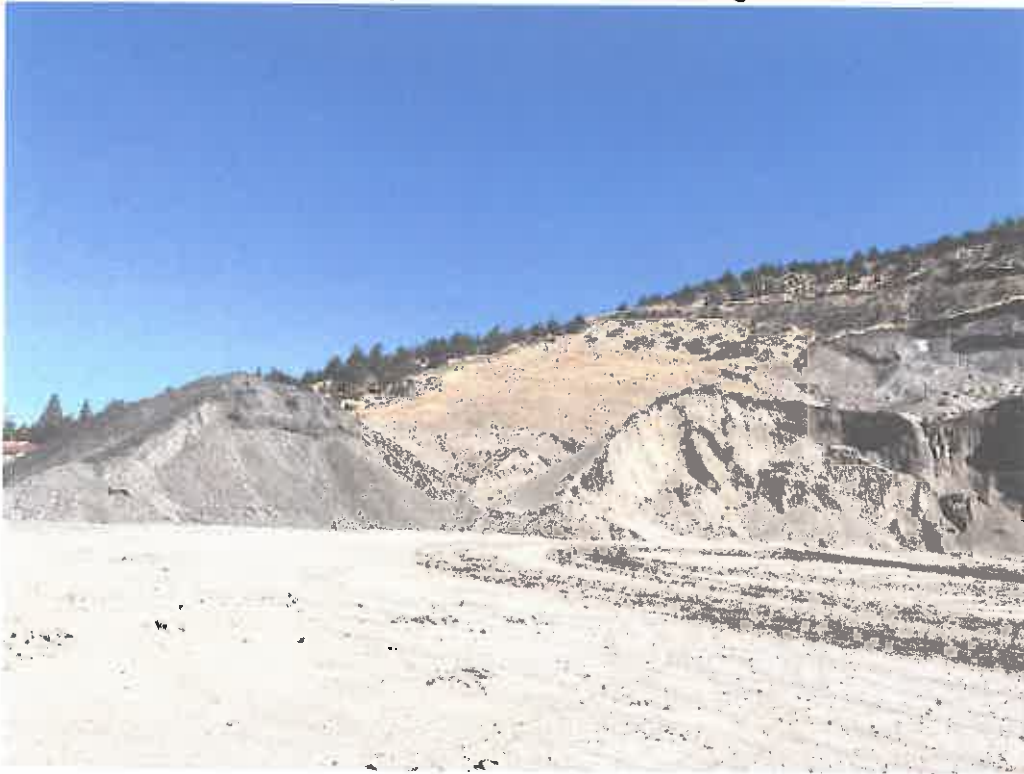
Photo 1- Revegetation to the north of the highwall.

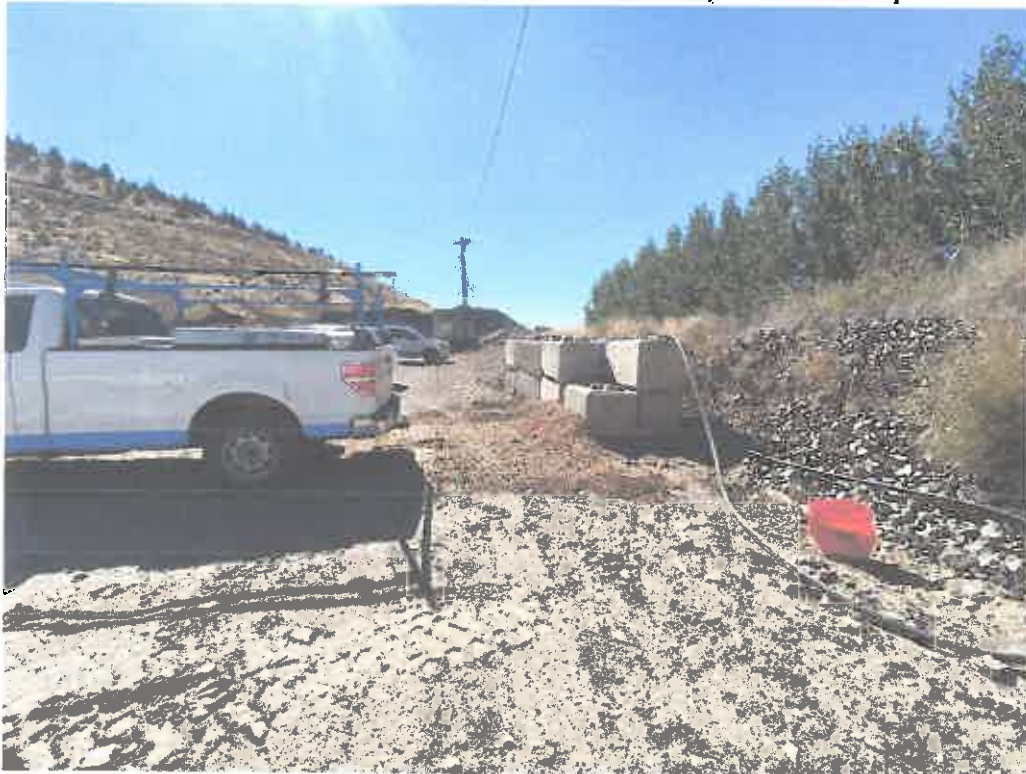
- a. Mining related disturbances such as stockpiling and storage of mining related equipment, was moved inside the permit boundary since the last inspection. The road built to reclaim the northern portion of the highwall was also reclaimed and revegetation efforts were successful.

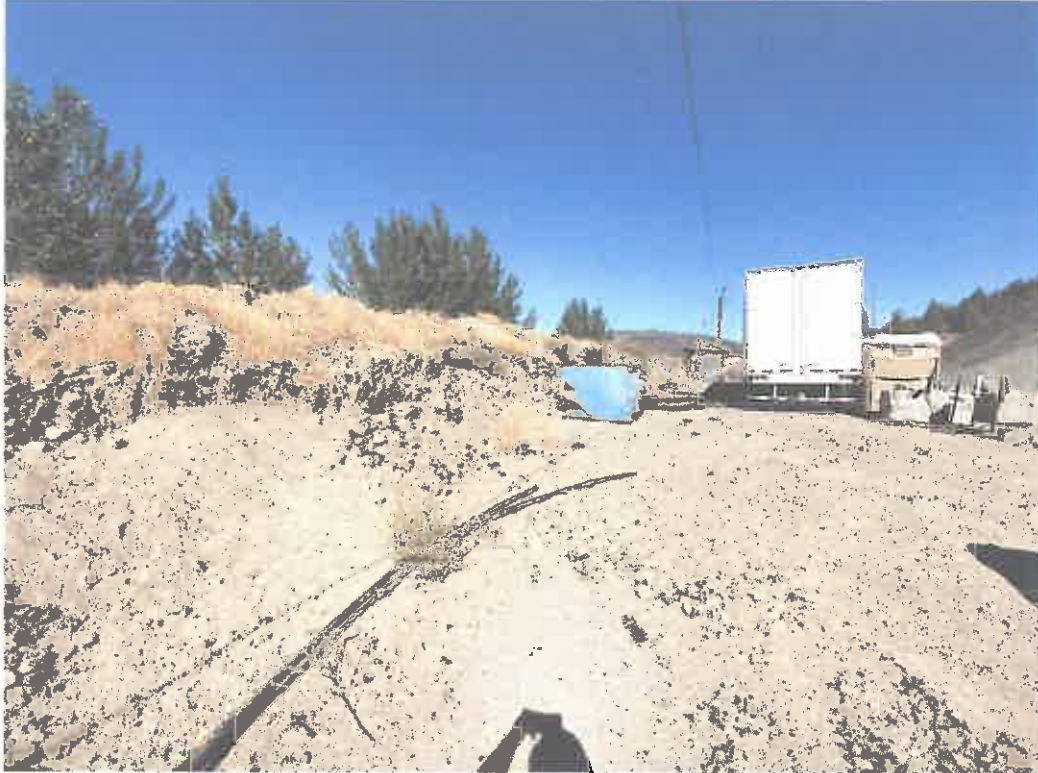
Photo 3- Stockpiles removed and mining equipment moved to trailer inside permit boundary.

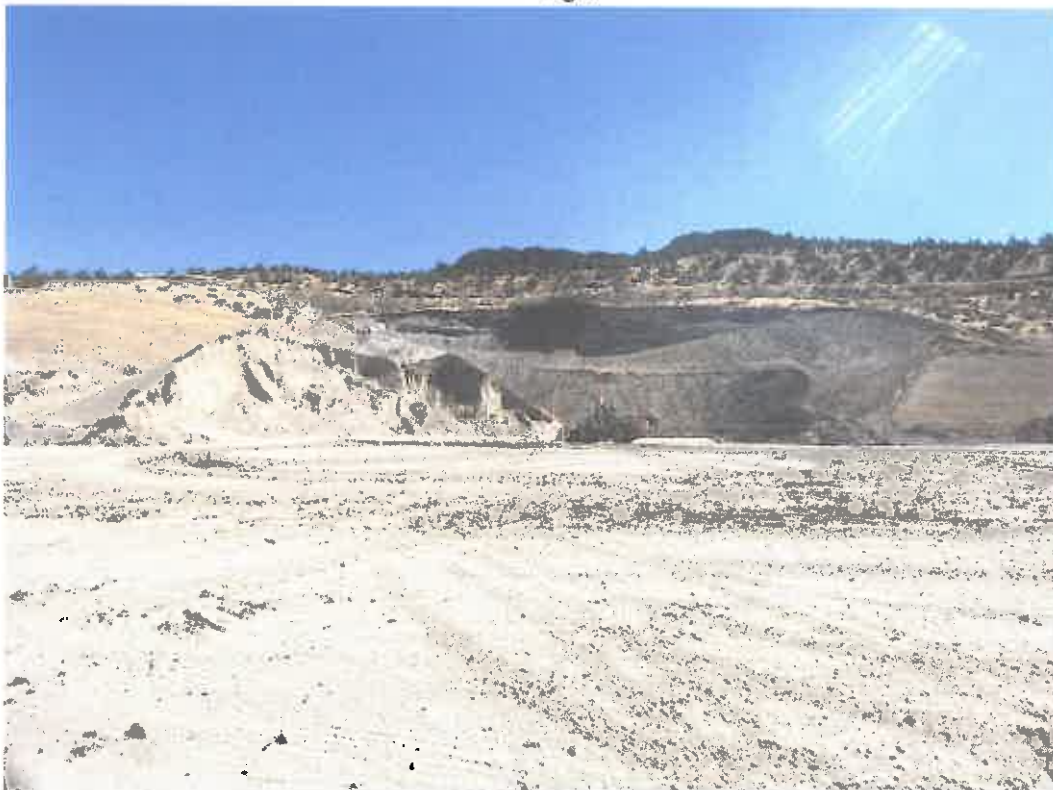
Photo 4- Highwall

The Permittee created a bench along the remaining highwall, roughly halfway up (photo 4). The average slope was approximately 1.5H: 1V to 1.7H: 1V (Horizontal: Vertical). Although the average slope meets minimum requirements, it should be noted that approximately the top 30-40 feet of the highwall was near vertical. Material was actively raveling from the face during the inspection. We discussed how to stabilize the slope, which included potentially filling in the quarry until a stable sloping configuration was reached. Alternatively, the Permittee could apply to expand the permit boundary further east along with the planned expansion to the south, expand the road above the mine site further into the hillside for continued use, and then lay the highwall back until it reaches a stable sloping configuration of approximately 1.5H:1V. The Permittee stated that this option would be preferred and would make reclamation of the slope easier.

- a. The average slope of the highwall was approximately 1.5H:1V. It should be noted that the top 30 feet of the highwall was near vertical and actively raveling during the inspection.

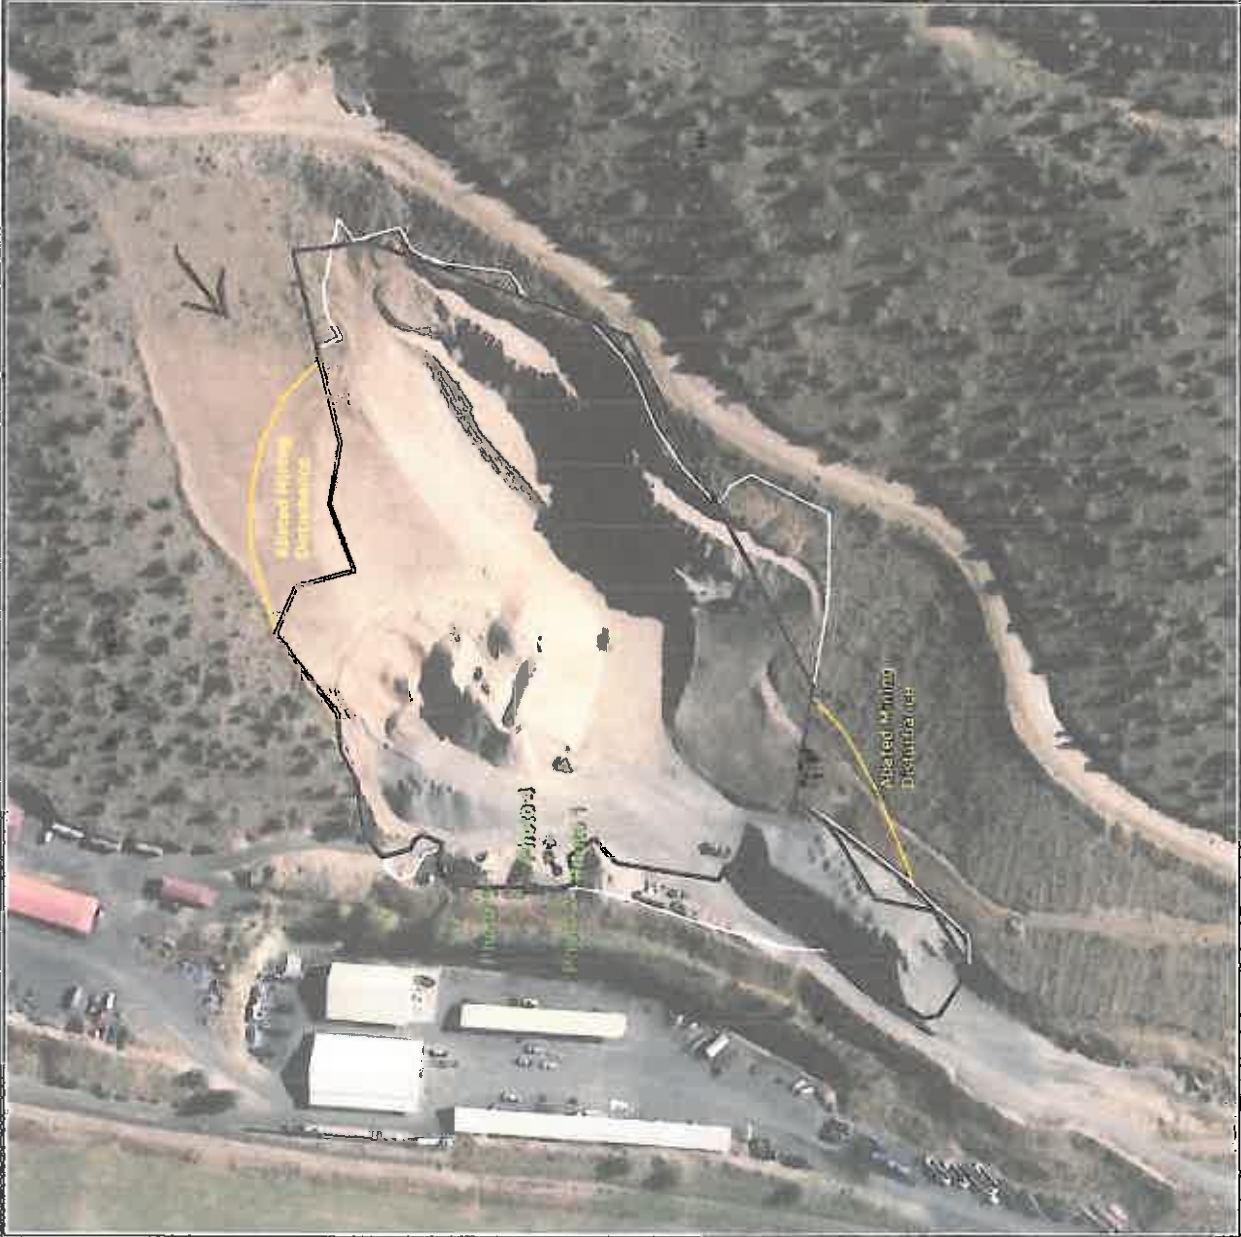
The enclosed GIS aerial from 2022 recognizes 9 acres covered under the Operating Permit, of which approximately 9.8 acres are currently disturbed by mining related activity and subject to reclamation requirements. The current bond is considered adequate at this time.

Symbol	Layer	Data Source	Source Date	Acres
[Symbol]	Survey Permit Area	Survey	1/25/2022	9
[Symbol]	Approx. Permit Area	---	---	---
[Symbol]	Proposed Permit Area	---	---	---
[Symbol]	Setbacks	---	---	---
[Symbol]	Excavation Area	---	---	---
[Symbol]	Limited Exemption	---	---	---
[Symbol]	Reclaimed	---	---	---
[Symbol]	Disturbed Total	Site Inspection	9/26/2024	9.8
[Symbol]	Outside of Permit Area	---	---	1

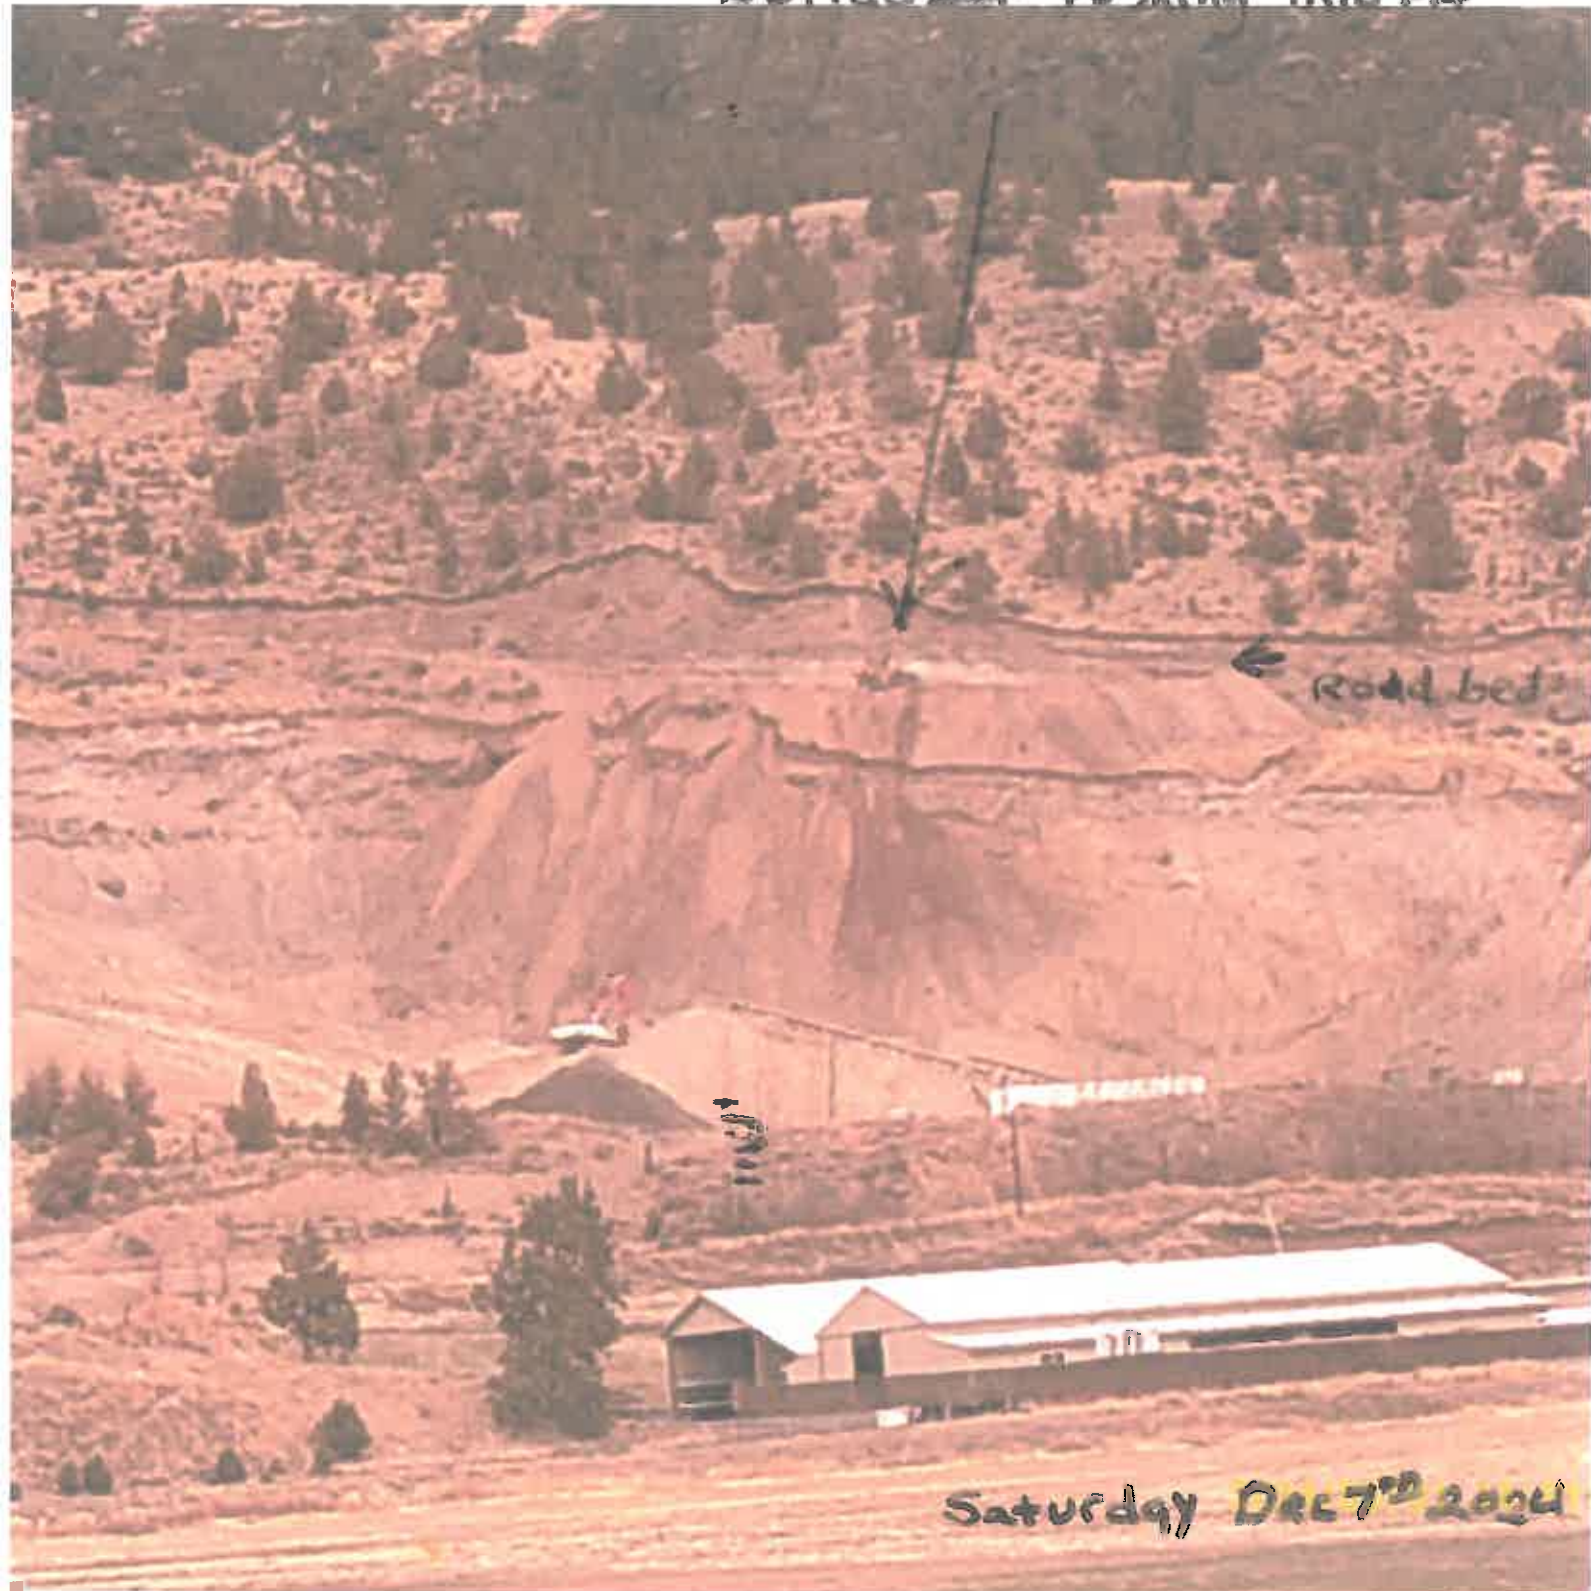
Saturday Dec 7th 2024

Bulldozer Pushing Into Pit

They testified at the county planning hearing in Nov. for the proposed expansion that they were running out of material in their present site. They have since gone above the permit area and pushed hundreds of tons of material down into the pit. The road bed, as you can see in the dogami latest inspection photo, slightly arches upward above the area. In the picture I sent from 1-6-2025 the roadbed now dips significantly where they have excavated a significant number of feet above the permit area and pushed it into the pit. Since the Sept. dogami inspection they had worked multiple Saturdays pushing material over the edge down to the bottom of the pit and sorting it to have it crushed while they had the crusher there. An extensive amount material in their current stockpiles came from outside the permit area.

In the recent photo you can see material strewn down the hillside that looks different from the what was there at the inspection. On the upper south end they had created a spillway for the material to slide down to the bottom of the pit. Also notice in the picture the amount of area actively disturbed. They have undercut some more of the pit wall, that was said to show progress towards reclamation during the inspection, and created even more cavitation.
