Comprehensive Plan, Map, and Text Amendments

The subject property is a 77.98 acre parcel, currently zoned EFU-2. The subject parcel contains approximately 1.8 million tons of concrete quality aggregates. Applicant is requesting that the county amend its Comprehensive Plan to add the subject parcel to the Inventory of Significant Aggregate Sites, adopt a site specific ESEE analysis, and authorize mining, subject to approval of a conditional use permit.

**AGGREGATE RESOURCE INVESTIGATION
VANIER SITE
PRINEVILLE, OREGON
2019-2020**

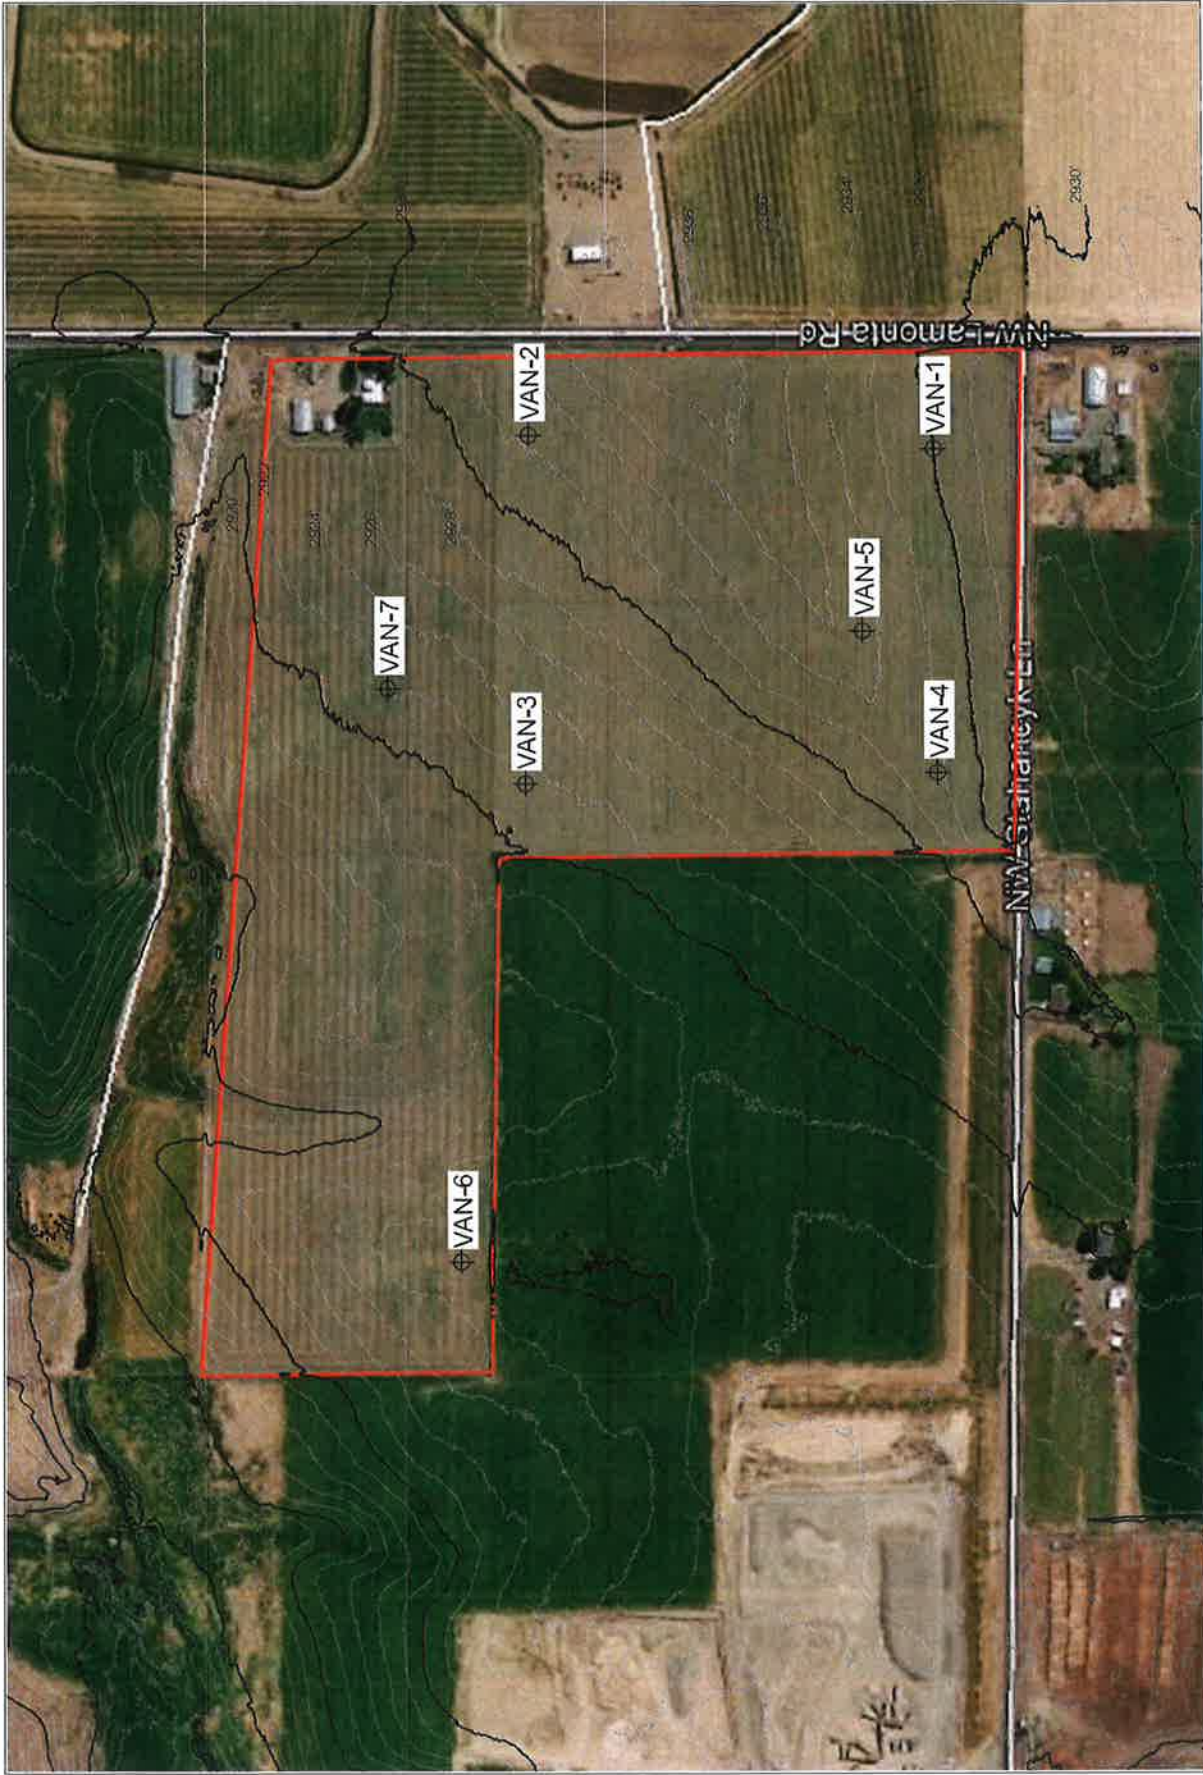
Figure 2. Drill Locations
Vanier Site
July 2020

The Vanier Site is shown in Figure 2 along with the marked locations of the test borings that were used to evaluate the aggregate resource. The site investigation was conducted by drilling bore holes and collecting continuous samples in order to determine aggregate resource thickness, overburden thickness, and to provide samples for resource quality analyses. The locations prefixed with 'VAN' were drilled on June 12-13, 2019. All drilling and sample collection was overseen by an Oregon Registered Professional Geologist. The topography shown with 2-foot contours on Figure 2 was obtained from publicly available Lidar data⁵.

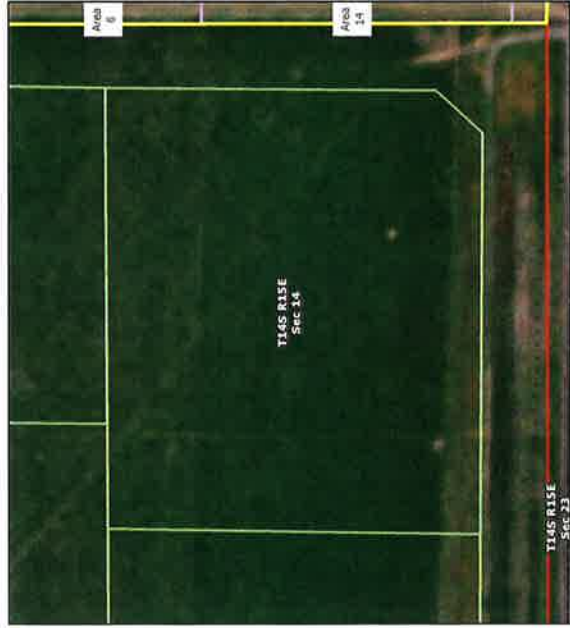
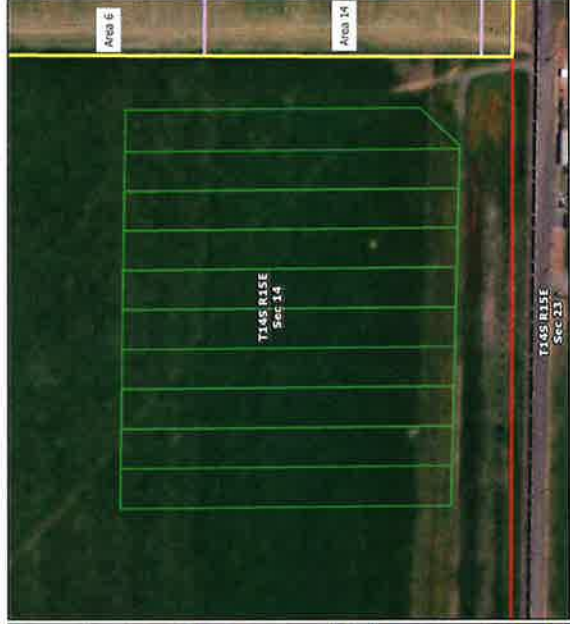
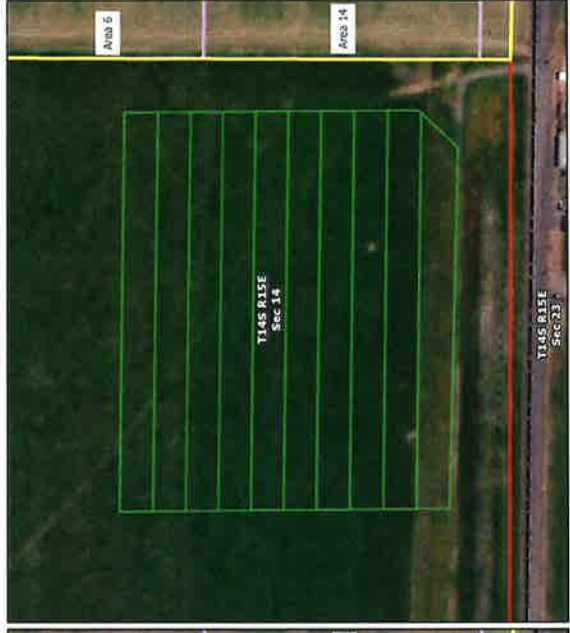
Figure 4

Mining Approach 1: Total Mine Block

Mining Approach 2: Trenches mined from East to West

Mining Approach 3: Trenches mined from North to South

Only one mining approach was considered at Vanier. Each mining area was analyzed as a whole, rather than separating each mining cell into a series of trenches as discussed for the Woodward property. Contemporaneous reclamation (backfill of the previously mined cell) was assumed. Analytical groundwater equations (modified Theim equations for unconfined aquifer conditions (Driscoll, 1986)) were applied to the individual mine cells and used to estimate groundwater inflows to a rectangular mine block. Two scenarios were considered for this mining approach. Scenario 1 used an R-value of 1,000 feet and used a low and high hydraulic conductivity. Scenario 2 uses an R-value of 4,000 feet and similarly used a low and high hydraulic conductivity value. By using different hydraulic conductivity values, Wenck was able to estimate the range in groundwater inflows that could be encountered given varying hydrogeologic conditions across the site. The results of our analysis are summarized in **Table 2**. Of the 14 mining cells analyzed, the modeling effort predicted a maximum inflow value of 288 gpm within Area 8, located in the northwest portion of the site. As shown by groundwater contours on **Figure 3**, increasing amounts of groundwater can be expected from southwest to northeast. The lowest inflow estimates were predicted by the model to be present within mining cell Area 11 with a range between 1.6 and 14.5 gpm. Inflow values are expected to be low in this area since it is the most westerly mining cell and groundwater increases towards the east. Knife River did encounter minimal inflows as they were mining Area 6 at Woodward. For mine planning purposes, these estimates do not consider the mitigative effects of backfilling to predicted inflow values and are reflective of worst-case scenarios.

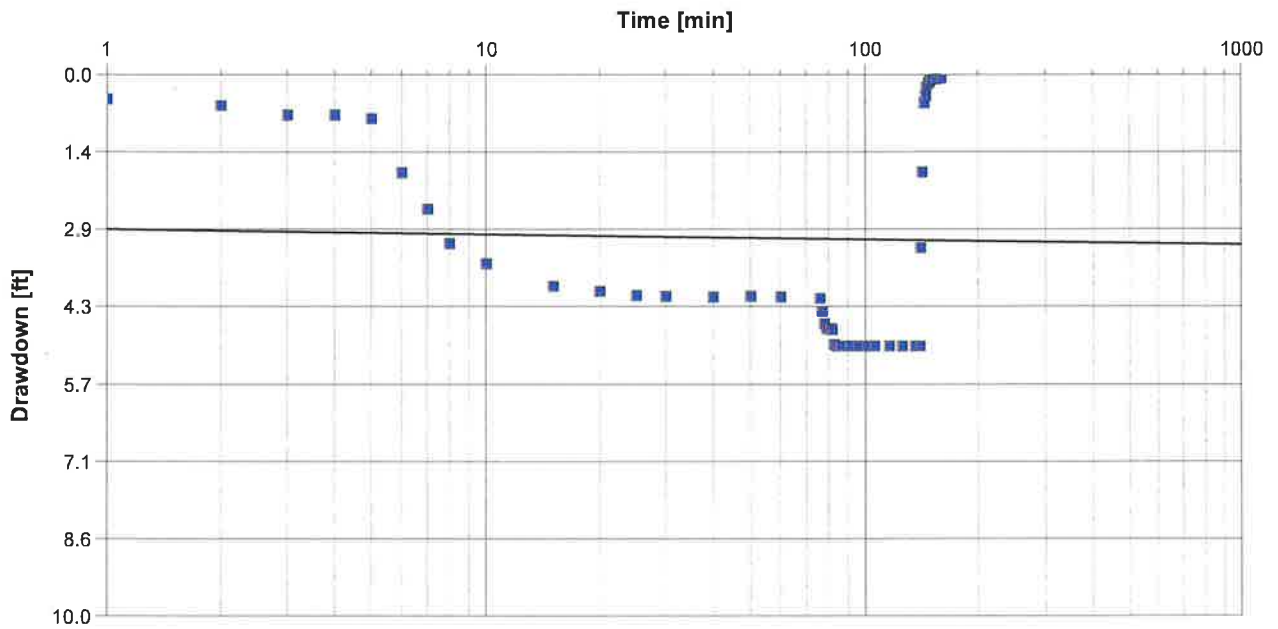
Location: Prineville, OR	Pumping Test: WW-1A Step Test	Pumping Well: WW-1A
Test Conducted by: FT		Test Date: 1/19/2021
Analysis Performed by: FT	WW-1A Step 1: Cooper-Jacob	Analysis Date: 2/9/2021
Aquifer Thickness: 10.18 ft	Discharge: variable, average rate 1.8821 [U.S. gal/min]

Calculation using COOPER & JACOB

Observation Well	Transmissivity [U.S. gal/d-ft]	Hydraulic Conductivity [U.S. gal/d-ft ²]	Storage coefficient	Radial Distance to PW [ft]
WW-1A	5.33×10^3	5.23×10^2	1.00×10^{-29}	0.17

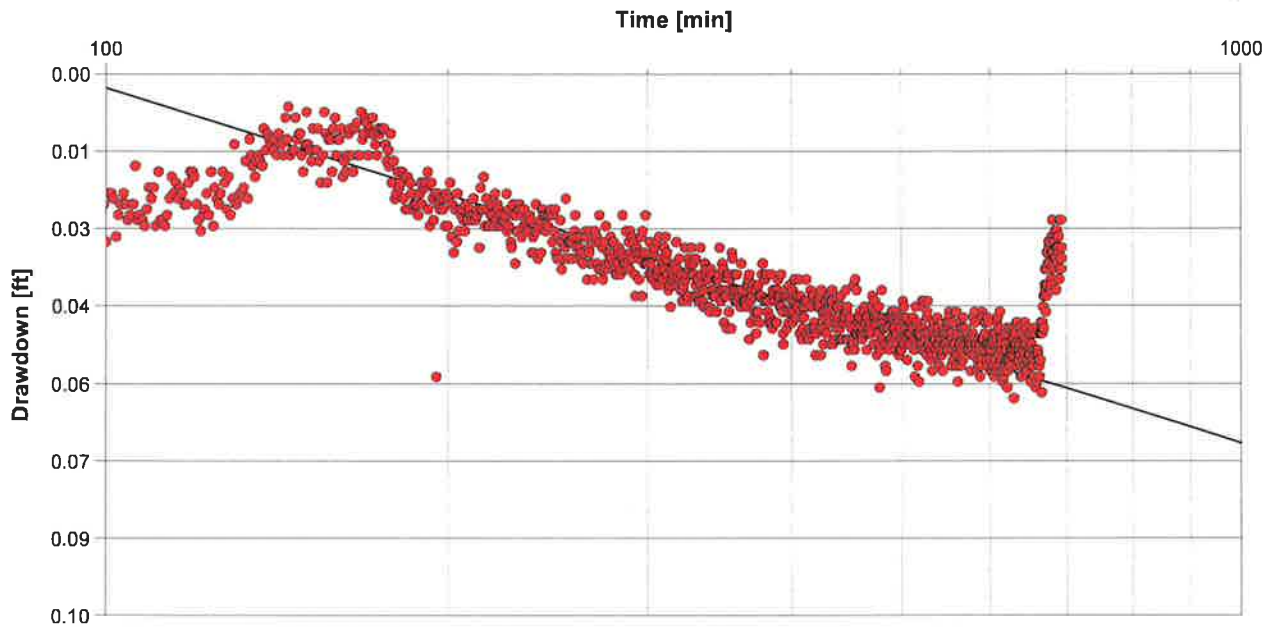
Location: Prineville, OR	Pumping Test: WW-1A Constant Rate Re-	Pumping Well: WW-1A
Test Conducted by: F. Tremblay		Test Date: 1/22/2021
Analysis Performed by: FT	WW-2A Cooper-Jacob 2	Analysis Date: 2/15/2021
Aquifer Thickness: 10.18 ft	Discharge: variable, average rate 2.4538 [U.S. gal/min]

Calculation using COOPER & JACOB

Observation Well	Transmissivity [U.S. gal/d-ft]	Hydraulic Conductivity [U.S. gal/d-ft ²]	Storage coefficient	Radial Distance to PW [ft]
WW-2A	9.84×10^3	9.67×10^2	2.85×10^{-1}	25.72
